Reading Spark Plugs

The following information is directly from the NGK website.

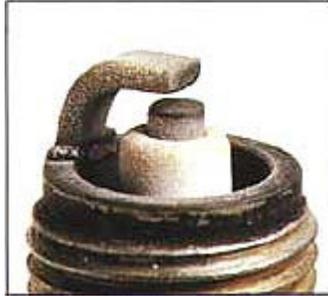
Normal Condition

An engine's condition can be judged by the appearance of the spark plug's firing end. If the firing end of a spark plug is brown or light gray, the condition can be judged to be good and the spark plug is functioning optimally

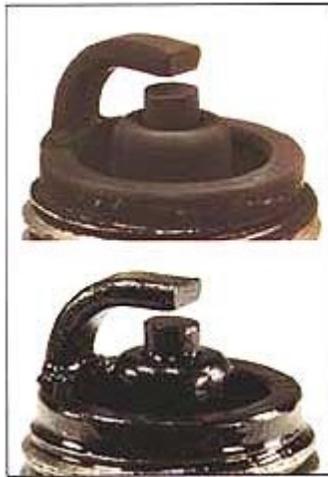
Dry and Wet Fouling

Although there are many different cases, if the insulation resistance between the center electrode and the shell is over 10 ohms, the engine can be started normally. If the insulation resistance drops to 0 ohms, the firing end is fouled by either wet or dry carbon.

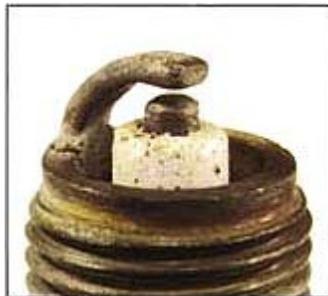
Overheating

When a spark plug overheats, deposits that have accumulated on the insulator tip melt and give the insulator tip a glazed or glossy appearance.

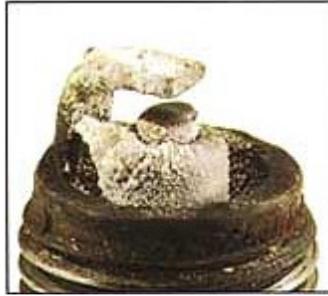
Deposits

The accumulation of deposits on the firing end is influenced by oil leakage, fuel quality and the engine's operating duration.

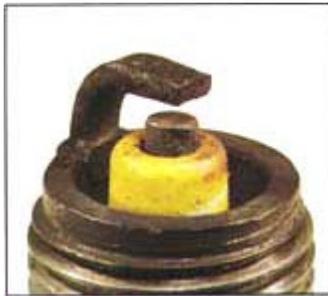
Lead Fouling

Lead fouling usually appears as yellowish brown deposits on the insulator nose. This can not be detected by a resistance tester at room temperature. Lead compounds combine at different temperatures. Those formed at 370-470°C (700-790°F) having the greatest influence on lead resistance.

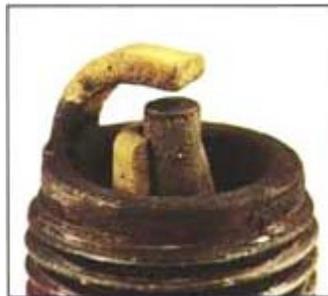
Breakage is usually caused by thermal expansion and thermal shock due to sudden heating or cooling.
